Re: Northwood Center School
Building Survey Findings
RPF File No. 22.1160

22.1160 Northwood Center School 053122 Hazmat Survey

TOWN OF NORTHWOOD
NORTHWOOD CENTER SCHOOL
820 1st NH Turnpike, Northwood, NH

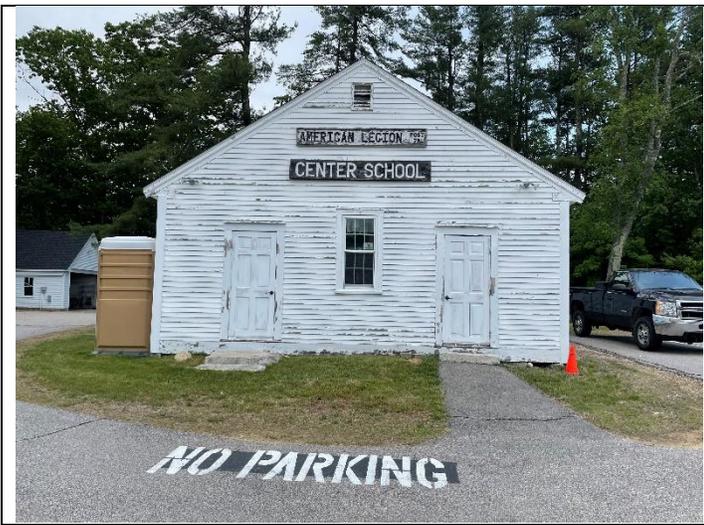
1. Front exterior view of the Northwood Center School.

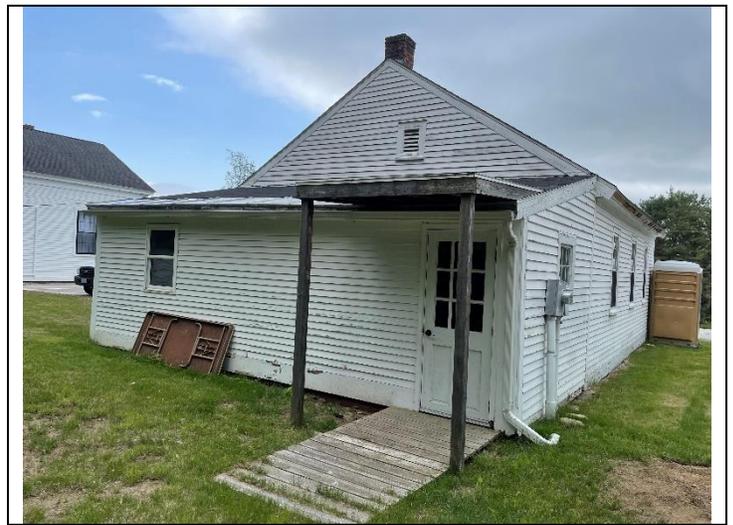
2. Rear exterior view of the building.

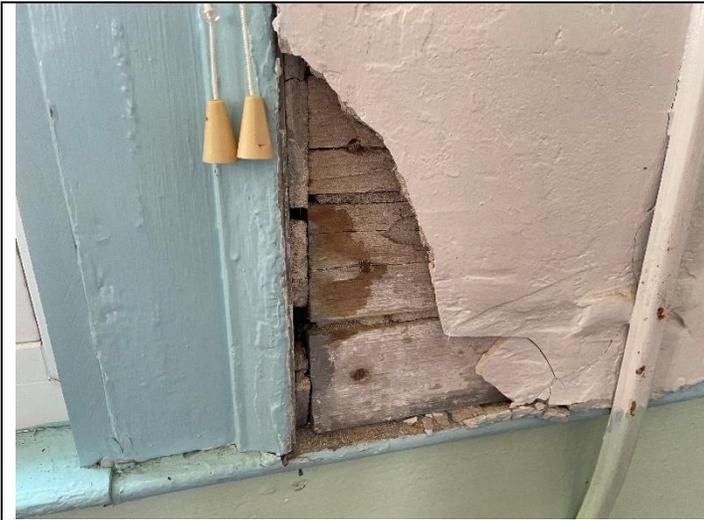
3. Closeup view of the plaster walls in the main hall.

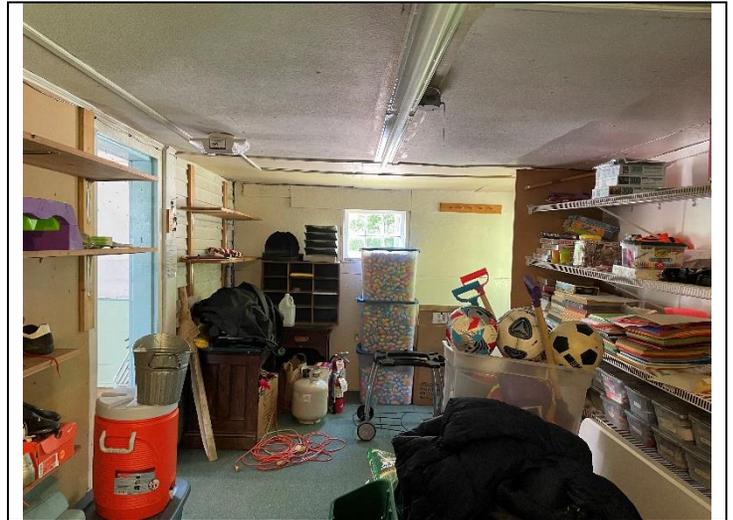
4. View of the back storage area.

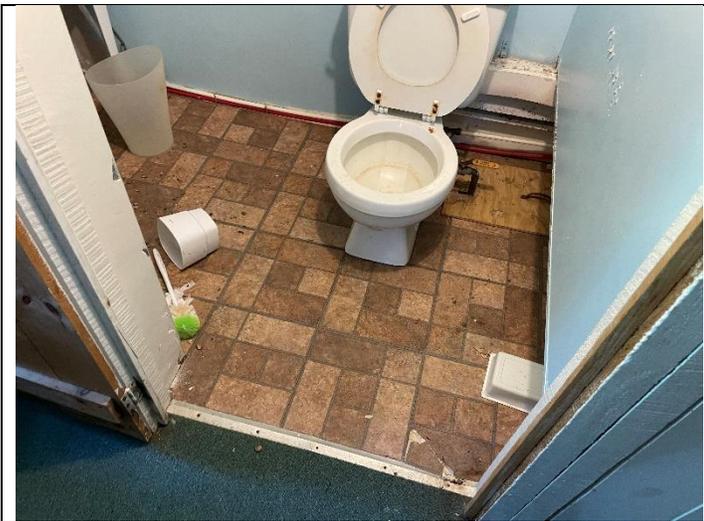
SUMMARY OF ACBM IDENTIFIED				
Building Material	Location	Approximate Quantity	EPA Category	Asbestos Results
Yellow Sheet Flooring	Bottom layer of flooring in bathroom	40 sq. ft.	Category II Nonfriable	10% Chrysotile

The ACBM identified during this survey consists of nonfriable material. The nonfriable ACBM was observed to be in good to fair condition and, left undisturbed and properly managed, is unlikely to cause any major fiber release episodes.

5. View of the bathroom flooring. ACBM yellow sheet flooring is located below 2 layers of other flooring.

ACBM that will not be impacted by renovation or demolition activity may be left in place if managed properly and if the materials are maintained in good condition. ACBM to remain in the building should be included in an asbestos management plan and operations and maintenance (O&M) program detailing the measures to be used to safely occupy the building until the ACBM is fully removed. An accredited Management Planner should prepare the O&M Program in accordance with the guidelines set forth in 40 CFR Part 763 (ASHERA).

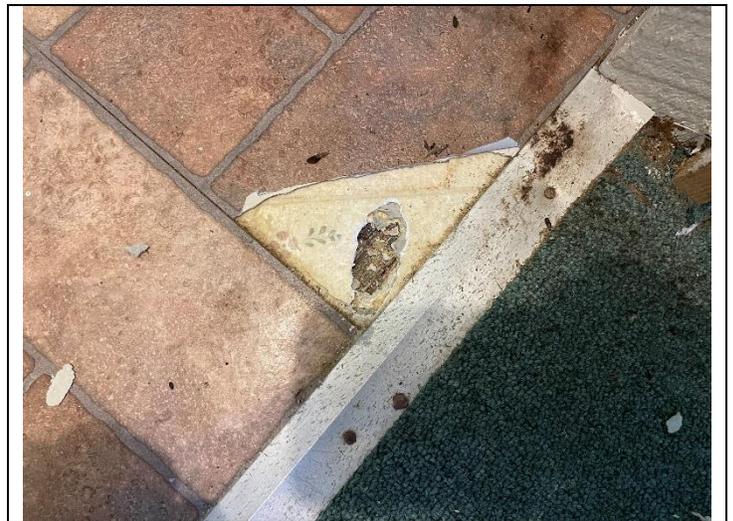
6. View of the layers of flooring in the bathroom.

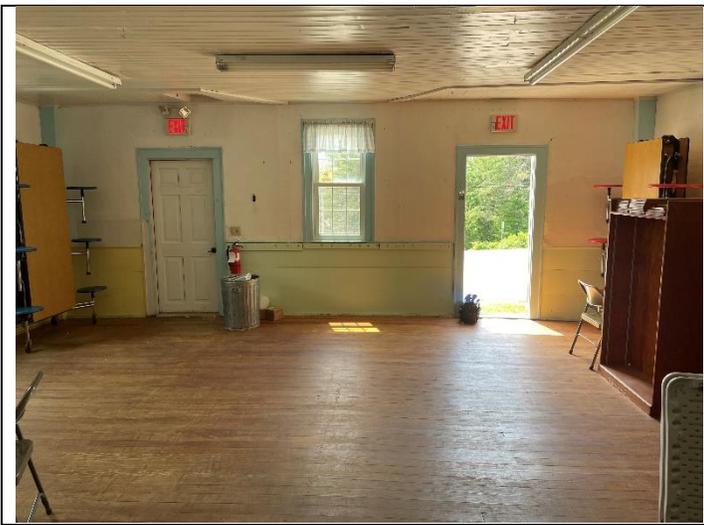
7. View of the main hall, facing the front of the building.

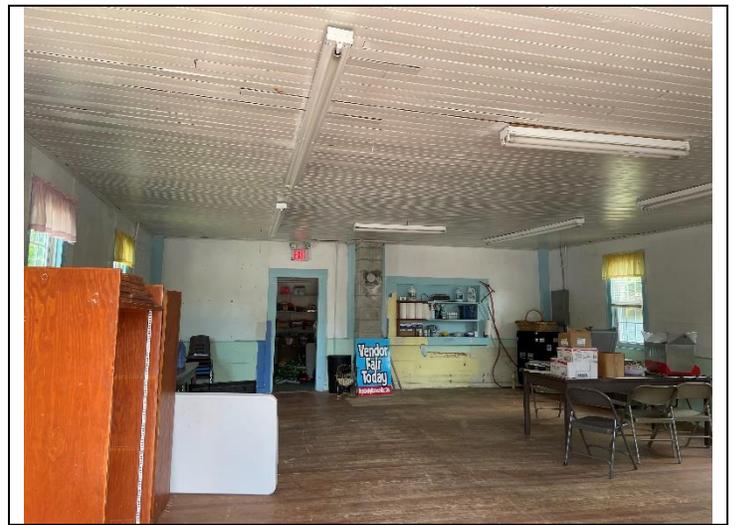
8. View of the main hall, facing the back of the building.
