NORTHWOOD ROAD SURFACE MANAGEMENT SYSTEM REPORT

This report was completed by the Town of Northwood in collaboration with Strafford Regional Planning Commission. Road Surface Management System assessments were completed in the town in August 2021, and the forecasting report was finalized in December 2021.

NORTHWOOD ROAD SURFACE MANAGEMENT SYSTEM

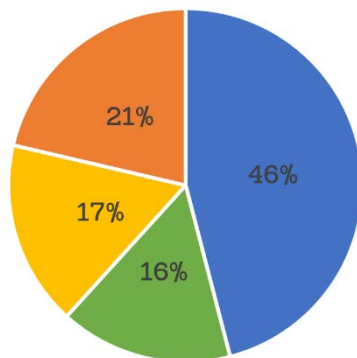
2021 Road Conditions

Northwood, in 2021, has approximately 30 total miles of town-maintained road and 27 Miles of paved roads. At the time of forecasting, approximately 46% were in excellent condition (PCI score: above 80), 16% were in good condition (PCI Score: 75-80), 17% were in fair condition (PCI Score: 65-74), and 21% were in poor condition (PCI Score: <65). 2026's projected PCI scores are going to leave Northwood in a very good place with 73% of their roads being either in good or excellent condition.

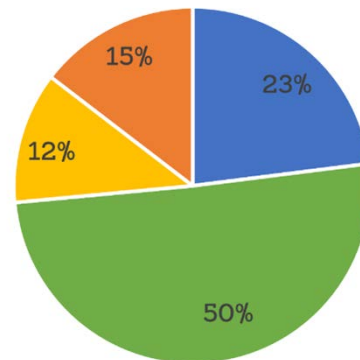
2026 Road Conditions

SADES RSMS plan updates and assessments are recommended to take place every five years. SRPC staff encourage municipal staff to keep detailed digital records of past road maintenance as well as future needs to be incorporated into and documented in report updates. Below is a map of road condition projection for 2026. Summer/Fall 2026 will be the next round of RSMS surveying.

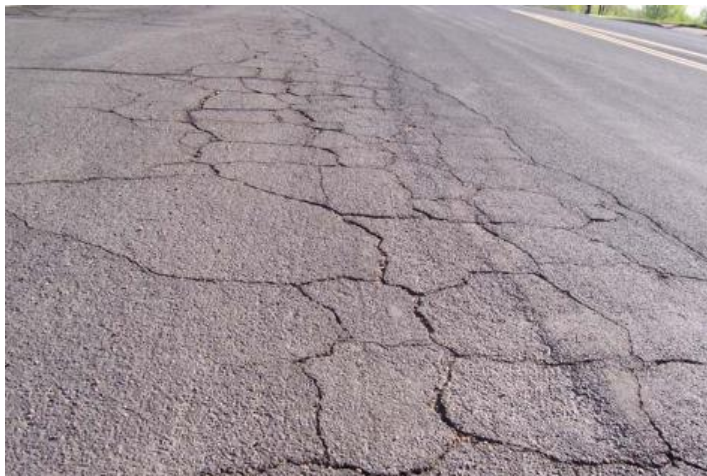
Medium Severity

| <u>Medium</u> | Easily discernible cracking with measureable crack <i>widths</i> up to 1/8" and some breakup. Pavement pieces, while loose, are still interconnected. |

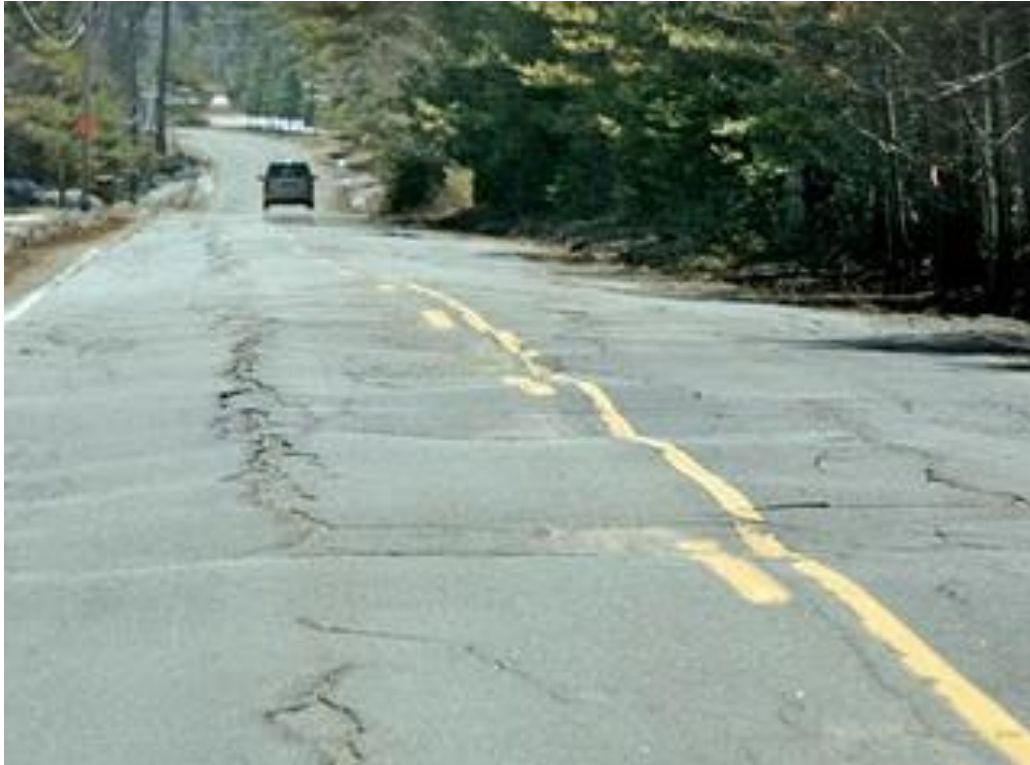
Frost Heave

None Interview with local knowledge does not identify this road segment as being prone to frost heaves.

Low Interview with local knowledge indicates that this segment is prone to minor frost heave severity, but does not affect vehicle travel.

Medium Interview with local knowledge indicates that this segment is prone to substantial frost heave severity and is just beginning to affect vehicle travel.

Severe Interview with local knowledge indicates that this segment is prone to major frost heave severity and clearly affects vehicle travel.
