Planning for police and fire facilities.

NORTHWOOD FACILITIES PLANNING

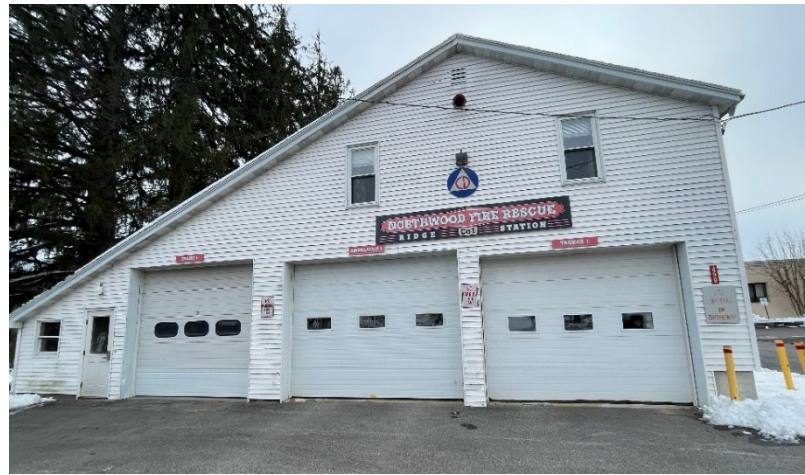
Ridge Fire Substation

Ridge Fire Substation: 499 First NH Turnpike

Primary Facility Deficiencies:

- Built in 1955 dangerously close to Route 4. The building has been hit. Apparatus have to cross into the road to back into bays.
- Station serves as the Emergency Operations Center (EOC). Not an ideal location due to proximity of the Elementary School.
- Bay doors are not big enough for standard ambulance. Modification of the building and vehicle was required for a new ambulance to fit.
- Medical supplies stored in a closet right off the bays, not the most sanitary.
- Only 1 bathroom means more time firefighters are exposed to carcinogens when returning from a fire.
- No space for a dryer or a gear room.
- Most bays too small for trucks coming from other communities to support mutual aid.

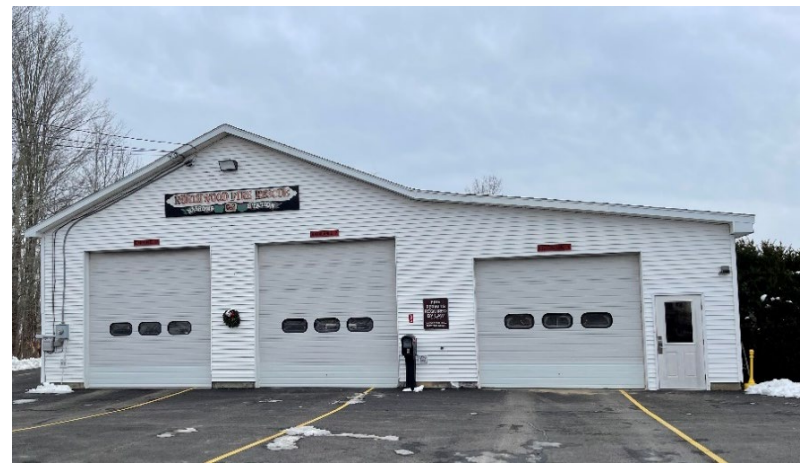
Narrows Fire Headquarters

Narrows Fire Headquarters: 85 Main Street

Primary Facility Deficiencies:

- Existing space is very tight. Station full beyond capacity. No space for additional or larger apparatus. Space constraints limit apparatus design.
- Low (6 ft) ceiling height in the Chief's office and mezzanine.
- Lack of ADA accessibility, private areas to hold meetings, and office space.
- Expensive breathing equipment requires a clean storage space. No suitable space for personal protective clothing.
- Lack of suitable accommodations for staff, with no heating in bunk room
- The building has only one restroom and no sprinkler system.
- Roof requires replacement, 1984 septic system shows signs of failure, vinyl siding is brittle and failing.

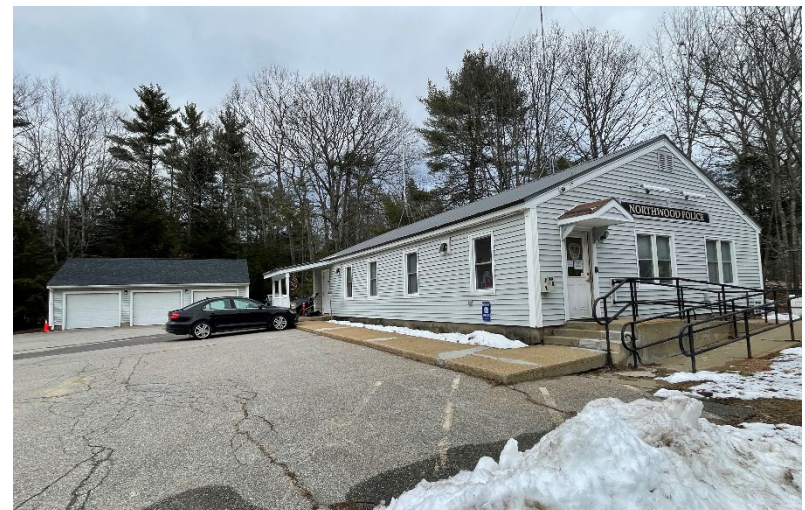
Police Station

1020 First New Hampshire Turnpike

Primary Facility Deficiencies:

- Security and safety a major concern.
- No sally port or controlled entry way.
- Evidence room is a deadbolted closet.
- Station lacks a holding cell.
- No security in building, holding area has quick access to building and exit.
- No fire suppression in the 3-bay garage, where file storage is located.
- Conference room serves as an interrogation room and has no soundproofing.
- No privacy is a liability issue when juveniles are present.
- Only 1 restroom for public and staff, often out of service.
